MISCELLANEOUS PAPER NO. 4-852

# EVALUATION OF HARVEY TWO-PIECE LANDING MAT (AM2)

November 1966

U. S. Army Engineer Waterways Experiment Station  
CORPS OF ENGINEERS  
Vicksburg, Mississippi

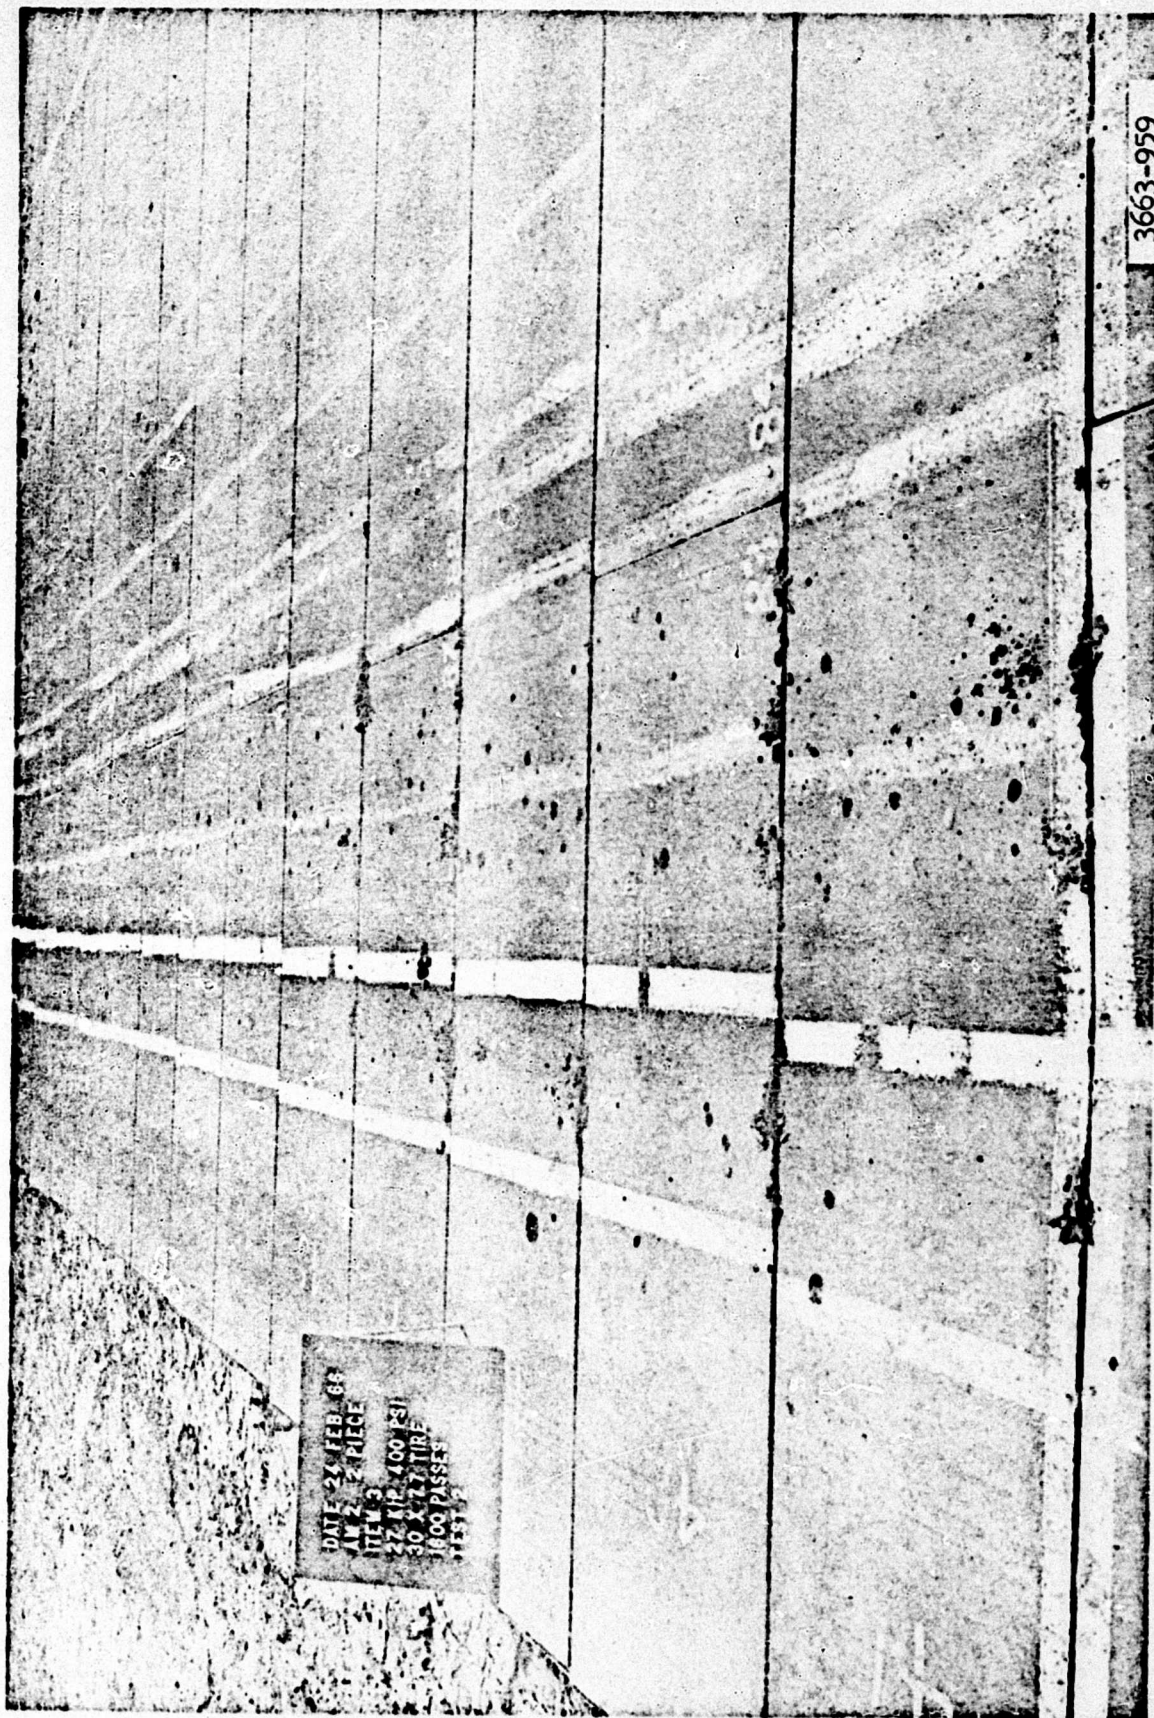
Photograph 15. Lane 2, item 3, after 1600 passes

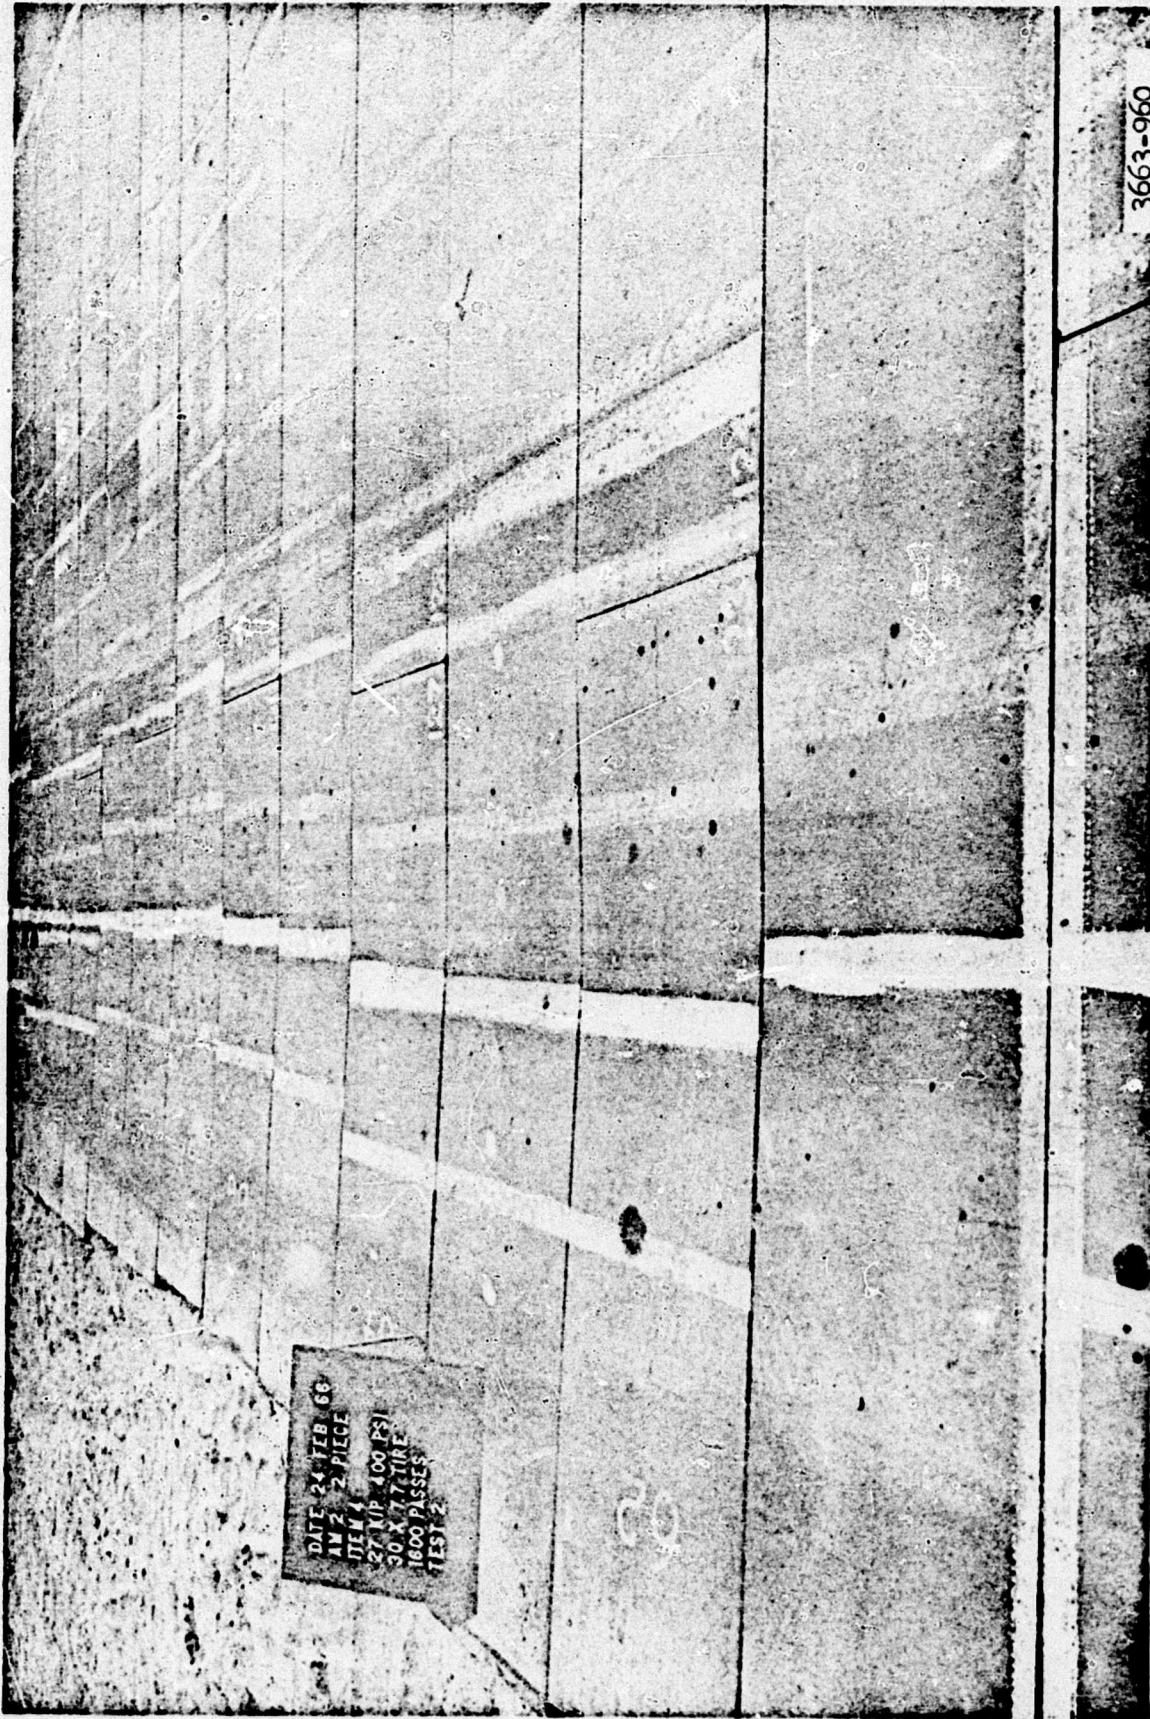
Photograph 16. Lane 2, item 4, at failure after 1600 passes

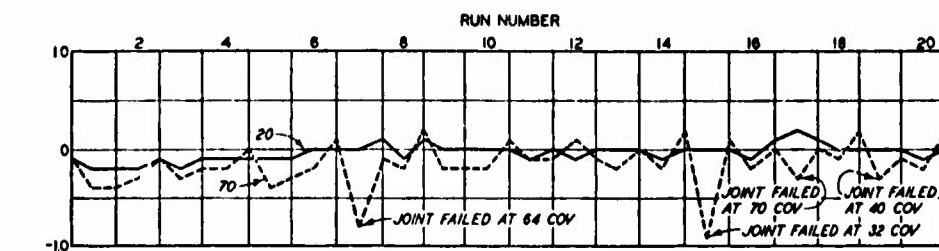
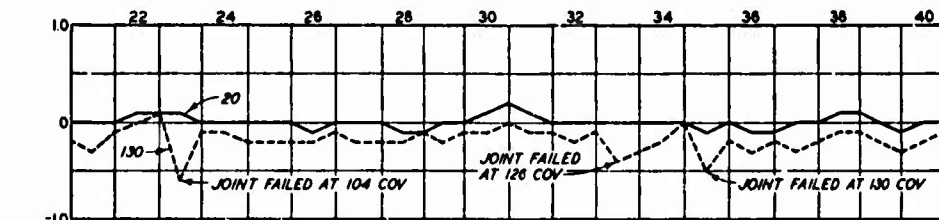
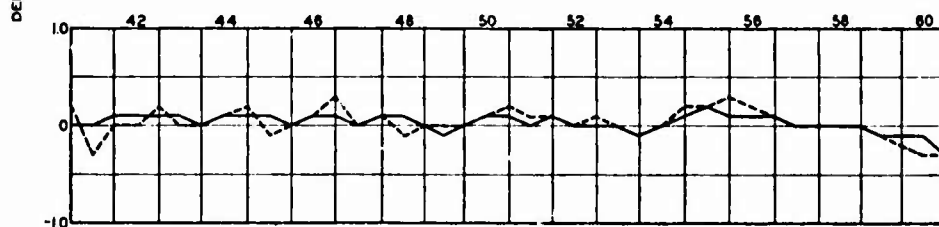
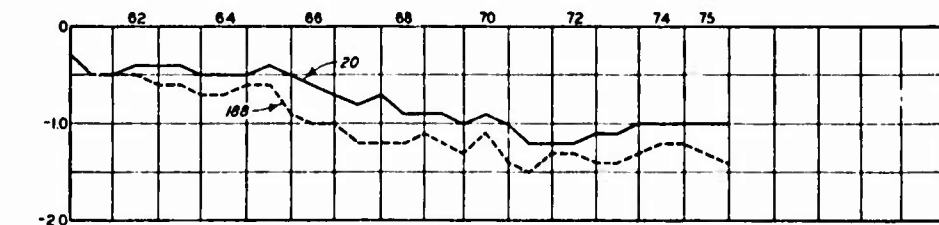
PERMANENT MAT  
DEFORMATION PROFILE  
TEST LANE 1  
UNIFORM-COVERAGE TRAFFIC

the mat as determined from level readings taken prior to and at various stages of traffic in test lane 1 are shown in plates 3 and 4. The center-line profiles in plate 3 illustrate mat deformation down the center of each test item. Since the mat was laid in a staggered pattern, every other run of mat consisted of two whole planks with an end joint located at the center line of the traffic lane. As can be noted in plate 3, the mat surface remained relatively smooth down the center line of all test items with the exception of a few abrupt depressions in items 1 and 2. These depressions were the results of end-joint failures in the mat planks. The overall deformation in test items 1, 2, and 3 (the clay subgrade) is very minor. However, permanent deformation varying from 0.5 to 1.5 in. is indicated for the mat over the sand subgrade in test item 4. As can be noted in the profile, most of this deformation occurred during the first 20 coverages of traffic, and was caused by the consolidation of the loose sand subgrade.

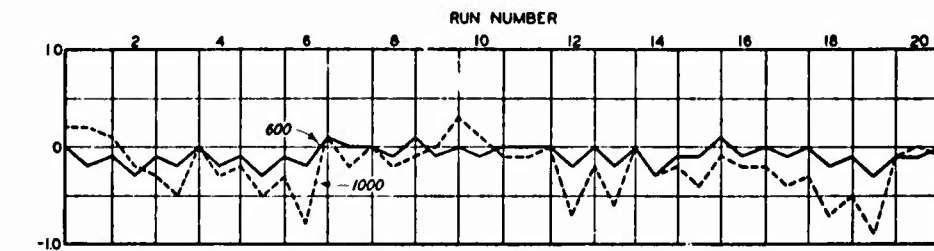
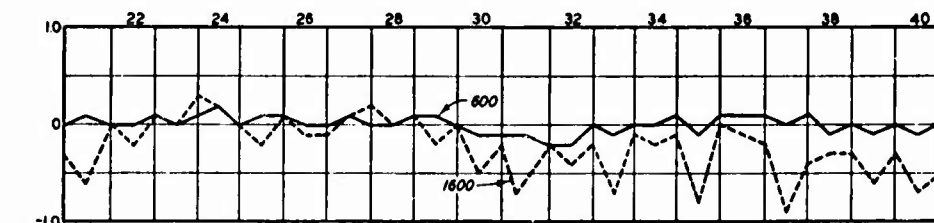
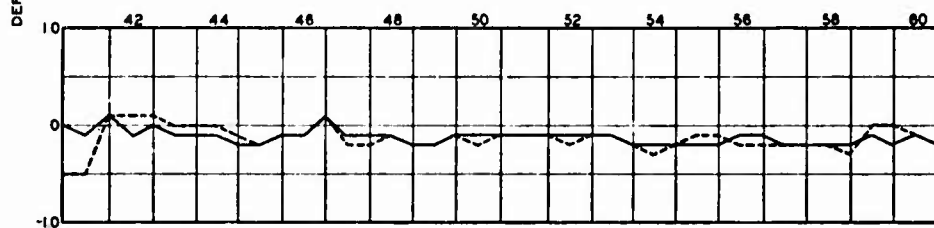
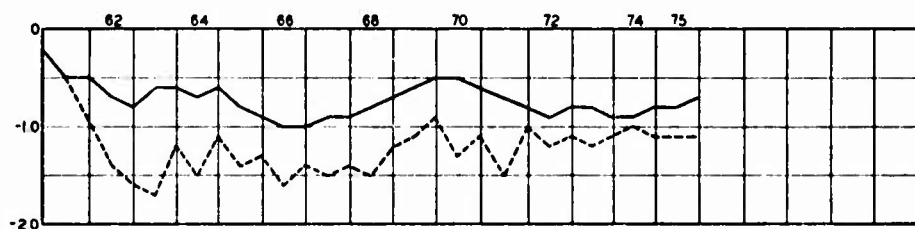
PERMANENT MAT  
DEFORMATION PROFILE  
TEST LANE 2  
SINGLE-LINE TRAFFIC

31. Permanent deformation. Profile plots showing permanent deformation along the center of the traffic path for items 1, 2, 3, and 4 of test lane 2 are shown in plate 6. These plots show that the mat surface in all test items remained relatively smooth for the first 600 passes of the load wheel, but by the end of traffic the mat was quite rough in items 1, 2, and 4 where core failures had occurred. The actual deformation was relatively small in all items except item 4 (the sand subgrade). The indicated deformation in this item of from 1 to 1-1/2 in. was caused by the consolidation of the sand which was initially placed in a loose condition.

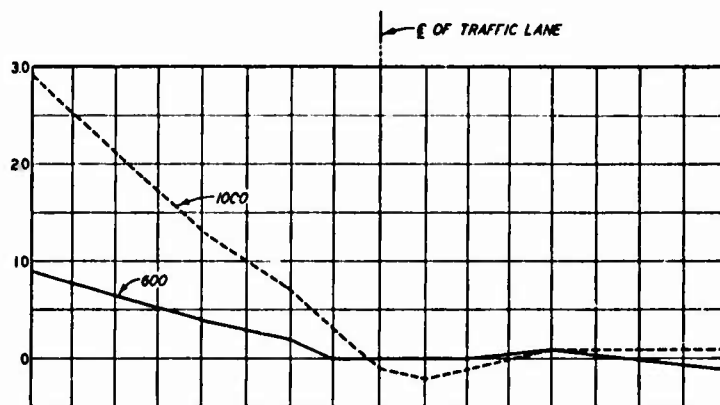
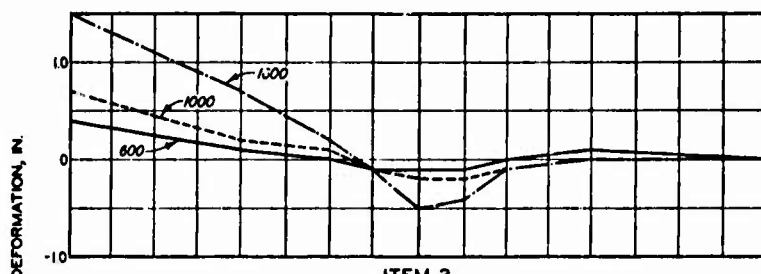
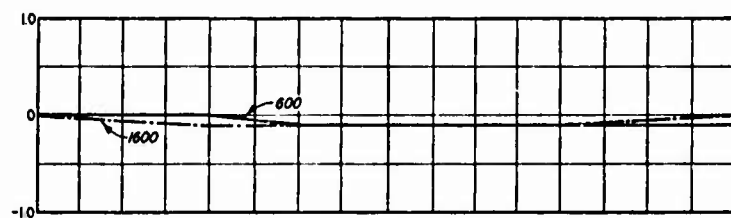
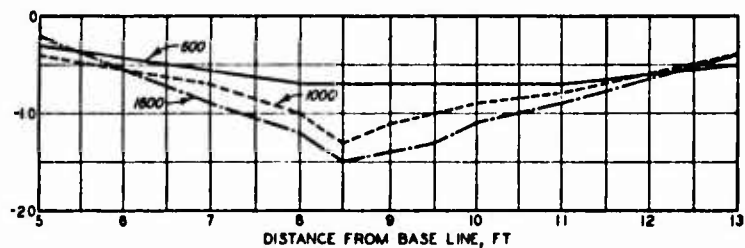
PERMANENT MAT  
DEFORMATION CROSS SECTIONS  
TEST LANE 2  
SINGLE-LINE TRAFFIC

32. Cross-section plots of permanent mat deformation across the traffic path at various traffic intervals are shown in plate 7. These plots indicate the severe bending and mat deformation that developed in test items 1, 2, and 4, as previously discussed (paragraphs 29, 30, 31), and also, the absence of deformation in test item 3.

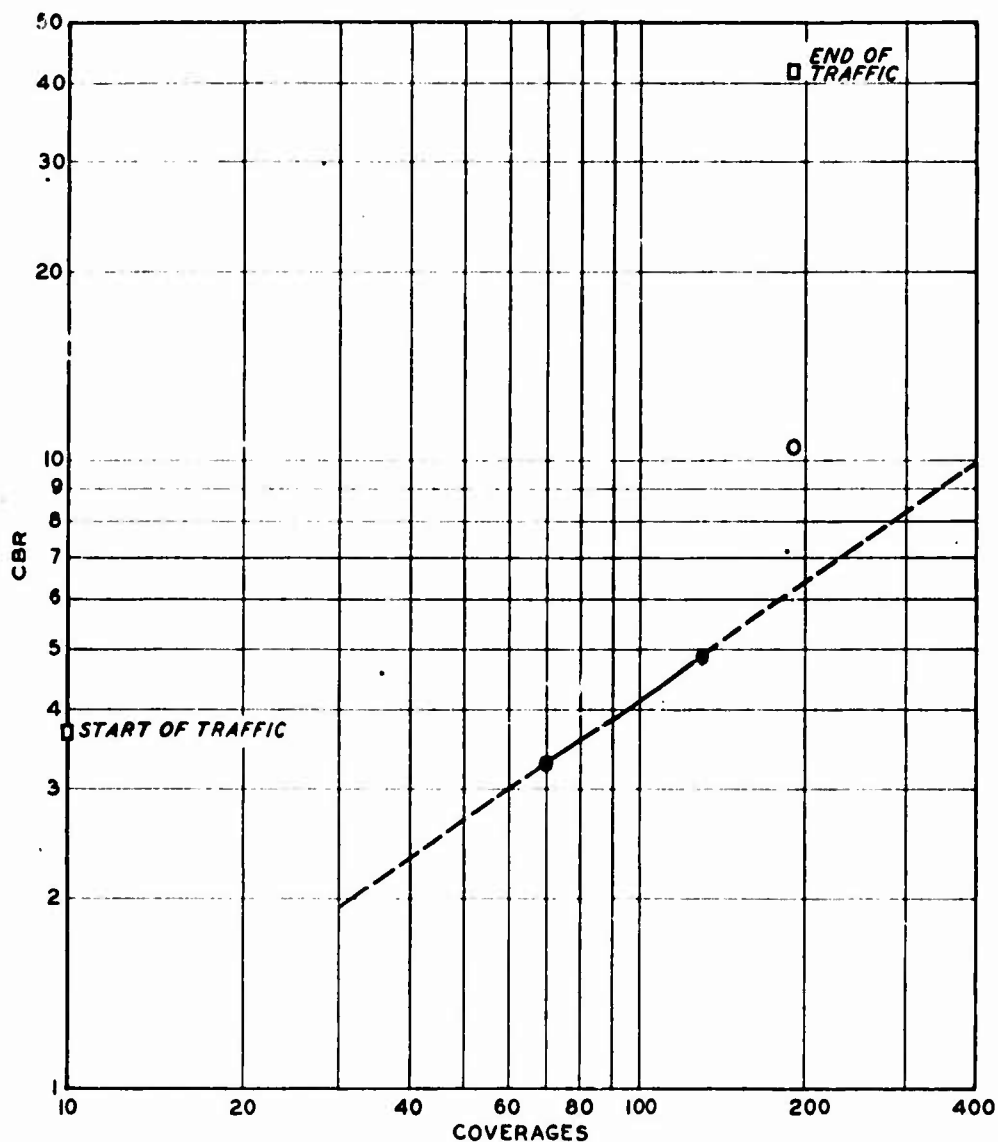
CBR VS COVERAGES  
TEST LANE 1  
UNIFORM-COVERAGE  
TRAFFIC

37. Service life. A plot of CBR versus coverages for the uniform coverage traffic with a 27,000-lb single-wheel load and 400-psi tire pressure is shown in plate 9. The points plotted are the rated CBR values listed in table 2 for the clay subgrade and the corresponding number of coverages at the end of traffic. The CBR at the beginning and end of traffic is indicated for the sand subgrade. The failure points are indicated by closed symbols, and a satisfactory condition is indicated by open symbols. From previous tests on landing mats, it has been established that CBR-coverage relations for mats result in essentially a straight-line relation when plotted to a logarithmic scale. Therefore, the straight line projected through the two failure points on plate 9 indicates the CBR required to support the test load for various coverage levels. The indicated CBR required to support 188 coverages of traffic is about 6.2.

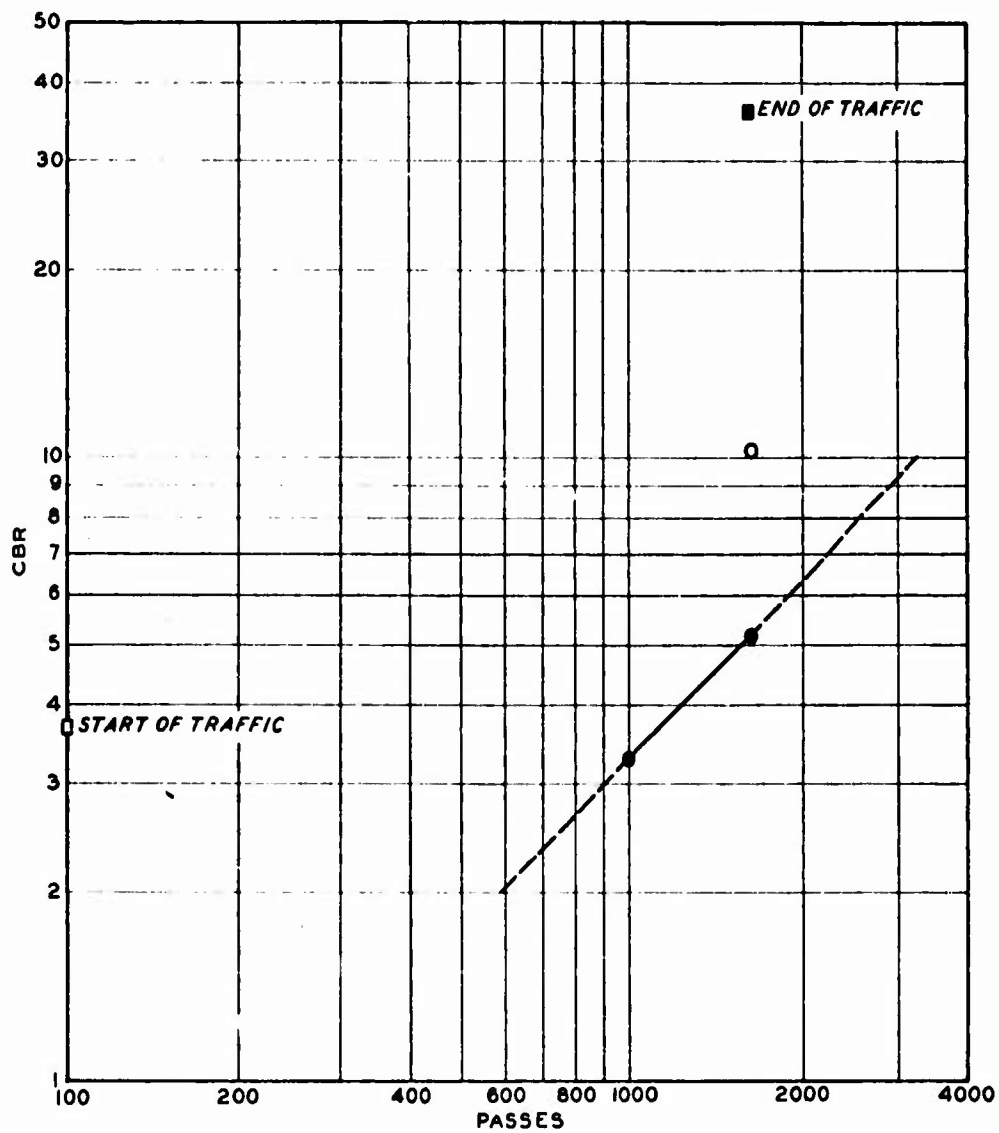
CBR VS PASSES  
TEST LANE 2  
SINGLE-LINE  
TRAFFIC

39. Service life. A plot of CBR versus passes of the 27,000-lb single-wheel load applied in a single track is shown in plate 10. From these data the indicated subgrade CBR required under the mat to support 1600 passes of the test load wheel is 5.1. In plate 10, it can be noted that mat failure did occur over the sand subgrade where the CBR value was 36 at the end of the traffic period. This failure was caused not by inadequate subgrade strength, but by settlement of the sand in the traffic path, which caused the mat to deform over the depression in the subgrade. This resulted in structural core failures in the mat planks.
